DEPARTMENT OF NATURAL RESOURCES
DIVISION OF OIL, GAS AND MINING

RE: Site Inspection, Ziegler Chemical and Mineral, Ziegler Gilsonite Mine, M/047/013, Uintah County, Utah

Date of Inspection: May 22, 2003
Time of Inspection: about 10:15 a.m. to 2:15 p.m.
Conditions: Mostly clear, 70-80's
Participants: Duane Boren (Ziegler), Stan Perkes (BLM), and Paul Baker (DOGM)

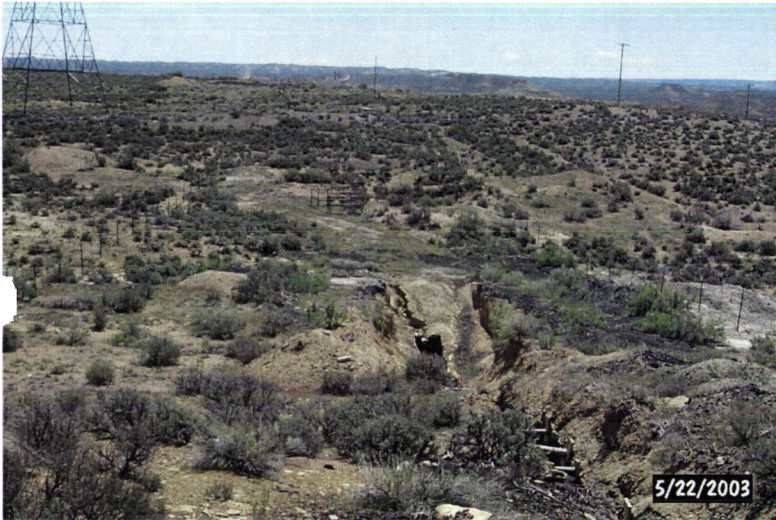
The area we examined had alternating open and closed trenches (Photo1). The operator has been working to fill these trenches which were apparently mined both before and after passage of the Mined Land Reclamation Act. Even in those areas that were not mined to the surface, the amount of remaining Gilsonite may be fairly small, but it is impossible to tell except in limited areas. Mr. Perkes was able to measure the thickness of the Gilsonite in one location, and it was about three feet deep and overlain by about two feet of soil.

Photo 1. The operator has been working to fill in the trench shown in the lower right portion of this photo. This is the same trench as in Photo 2.

There has been some concern whether the rock being used to fill the trenches would bridge and collapse later. Although this might happen, especially in narrower trenches, it did not appear to be a problem in the area we looked at. The operator should continue to fill the trenches and could use waste Gilsonite and concrete as long as the concrete is broken up enough that it doesn't bridge.

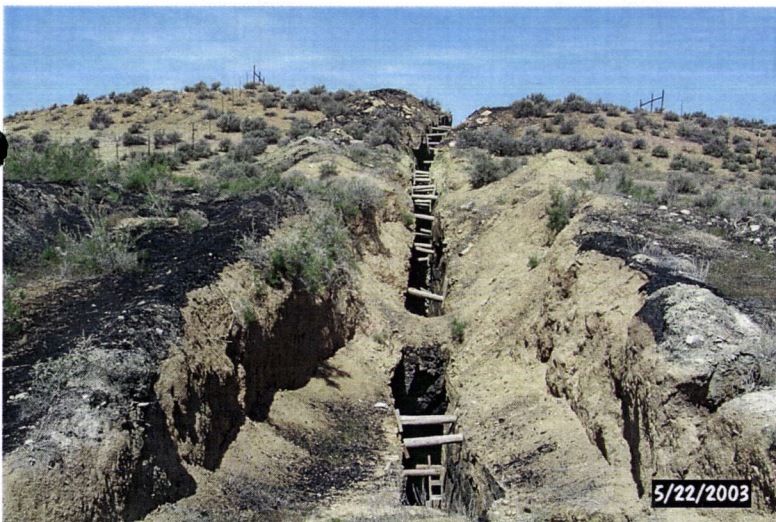
Photo 3 shows an area where the operator has filled the trench with rock, and Photo 2 shows where the operator has been putting rock from the Sterling Mine. There is still a ways to go before the trench in Photo 2 is filled.

Photo 2. An open trench the operator is filling.

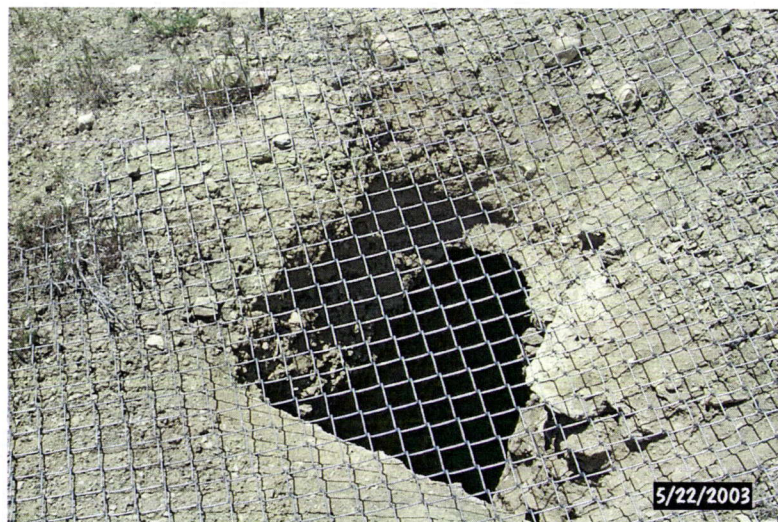
To the east of the area shown in Photo 1 but west of the CNV-1 shaft, there is an area where the operator has tried to close a shaft or trench with concrete. This is apparently in the area of an escapeway between the C-2 and C-3 shafts. There has been some piping around some of this concrete

(Photos 4 and 5), and the larger holes have been covered with chain link fencing. Although there are no fully open trenches in this area, we do not know how much Gilsonite was left or if there is just a layer of unconsolidated soil over the trenches or shaft.

Photo 2. One of the holes that have opened up near CNV-1.

In any areas where there is just a layer of soil over a trench or where the Gilsonite is thin, the operator needs to uncover the trench, potentially mining the last of the Gilsonite, then fill the trench. This is particularly true of the area near the CNV-1 Mine where holes have opened up. It will probably be necessary for the operator to dig the soil out of the trench in this area to see exactly what the conditions are.

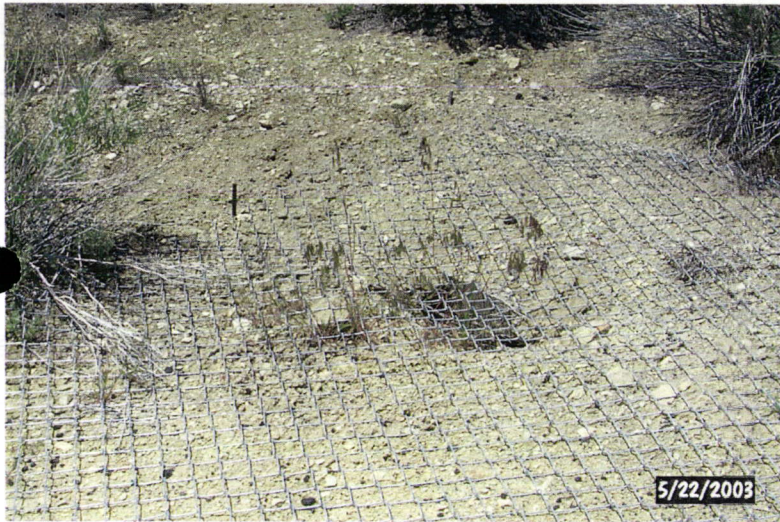
Photo 3. Another of the holes that have opened up.

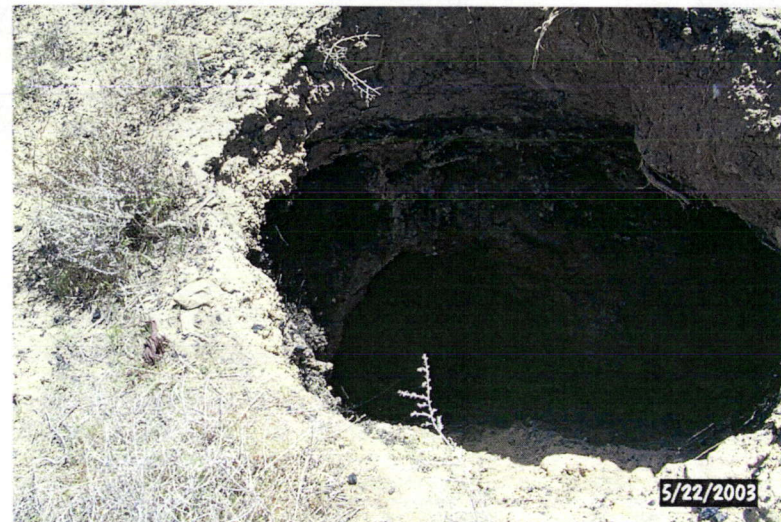
To the west of the areas shown in Photos 1, 2, and 3, there is a reclaimed trench where soil has been gathered from the sides and bermed over the trench (Photo 6). We did not know exactly what reclamation methods were used in this area and whether the trench was completely or just partially filled, but we saw some areas where soil has been piping into the trench, possibly into voids in rock used to fill the trench (Photo 7). Vegetation in this area consisted almost entirely of weedy species, but I do not know if the operator seeded it.

Photo 5. A hole where water has piped into the trench in Photo 5.

The piping shown in Photo 6 should be repaired, then the area should be monitored. This entire area should be scarified, left as rough as possible, and seeded in the fall.

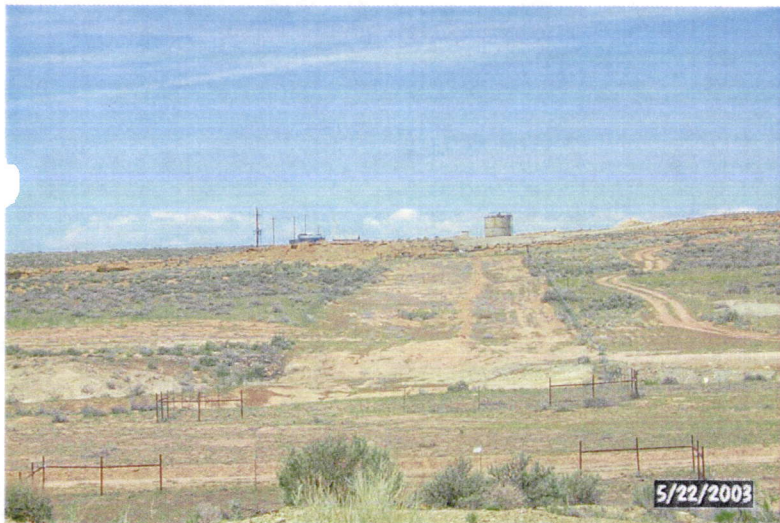
Photo 4. Soil has been scraped from the sides and bermed over a trench shown near the center of this photo.

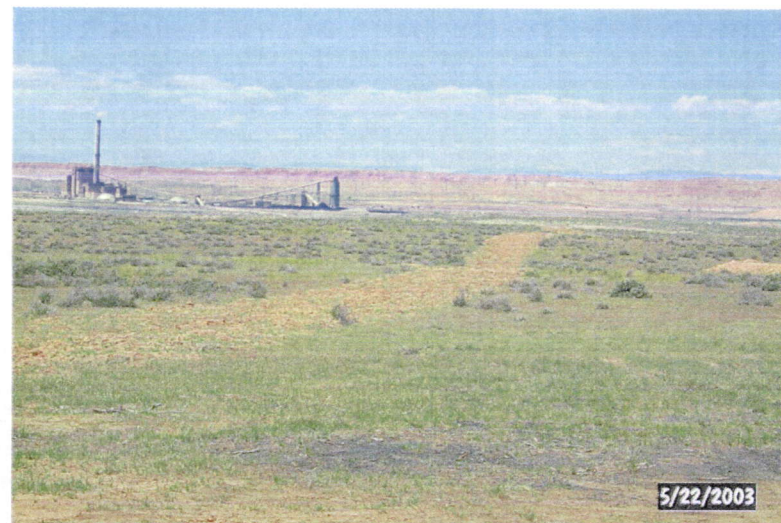
A little farther west is a reclaimed airfield and a shaft in the process of being reclaimed (Photo 8). I believe this shaft was part of the C-1 Mine. The airfield was nicely roughened, and some desirable species are starting to grow. We talked about what kind of permanent cover to put over the shaft.

Photo 6. Reclaimed airstrip.
